SUBJECT

Possible low power condition experienced with engine governing systems incorporating the AGB 250A3 integral actuator on 8 and 12 cylinder engines.

AGB 250A3

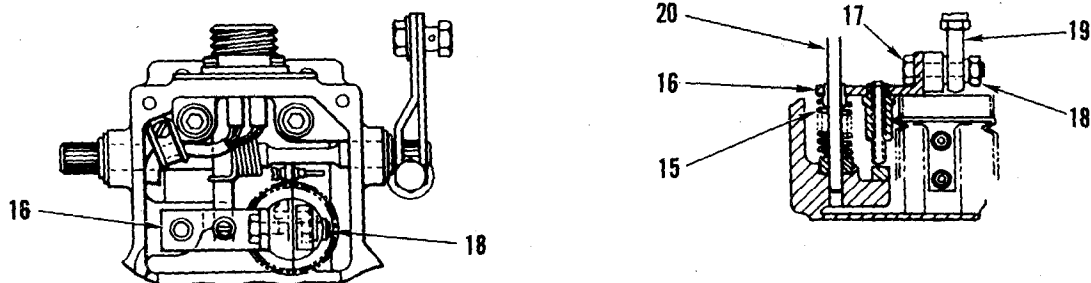
Figure 1

Recent product improvement was implemented partially by United Technologies Diesel Systems. The result may be that the fuel injection pump rack may only move part of its travel and may cause a low power condition at high actuator temperatures.

The present combination of the actuator's internal dust boot, spring and spring seat may cause a return force imbalance. The imbalance may prevent the fuel rack from moving completely to the full fuel position when the actuator is subjected to high temperatures. This condition is caused by the fact that a spring seat was prematurely installed. It should have been installed simultaneously with a new design dust boot.

- A. Remove rod end bearing (Pos. 19) by loosening its locknut (Pos. 18). Also remove shoulder screw (Pos. 17) and bracket (Pos. 16).
- B. Remove spring (Pos. 15) and its spring seat which rests against the actuator housing.

Replace spring (Pos. 15) with service part, SP 676. **DO NOT** re-install spring seat. Then re-install L bracket (Pos. 16), fasten rod end bearing (Pos. 19) with shoulder screw (Pos. 17) and locknut (Pos. 18). Torque to 4-5Nm (3-3.5 ft. lbs.).

NOTE: Check that L bracket (Pos. 16) is free to slide along spring retaining pin (Pos. 20) with no binding when rack is manually moved to maximum fuel position.

THIS IS AN IMPORTANT TEST - binding can cause loss of control resulting in engine damage.
