Model 100
Parts Bulletin P1

VA 8518A FUEL RETURN CHECK VALVE REPLACEMENT

Model 100 Fuel Injection Pumps on International Harvester Engines

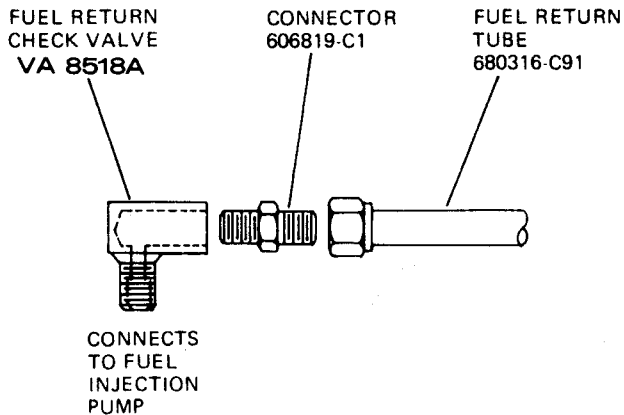
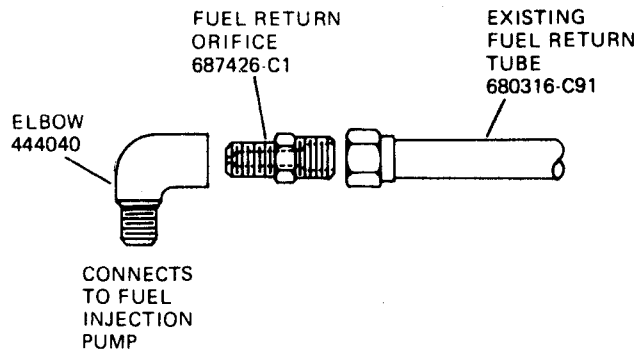
FIGURE 1.

When a VA 8518A requires replacement, the fuel return circuit should be updated in accordance with I.H. service bulletins for specific engine installations: Agricultural Equipment Bulletin No. S-3624, Truck Service Bulletin SLF-78-13 and Construction Equipment (Pay Line) No. 12H-78-02.

OLD Installation

NEW Installation

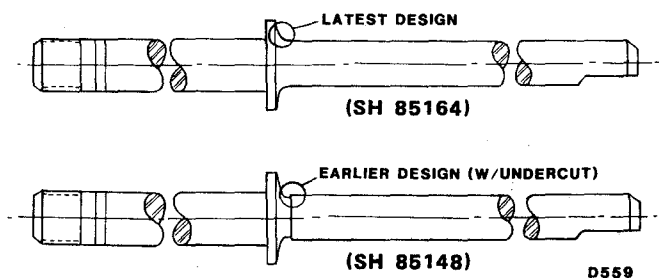
FIGURE 1.

The undercut in the Model 100 governor weight shaft has been eliminated. Latest shafts are now machined with a radius blend in that area. See Figure 1.

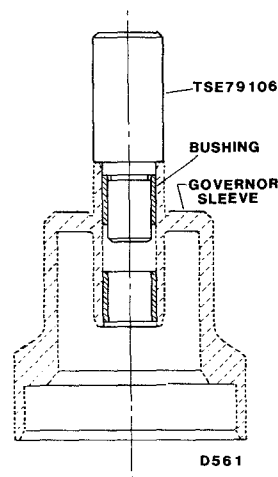
FIGURE 3.

Pressing tool, TSE 79106 can be used to correctly reposition the bushing in governor sleeve, SV 8522A. See Figure 3.

Use TSE 79106 to correctly position the bushing and to maintain concentricity.

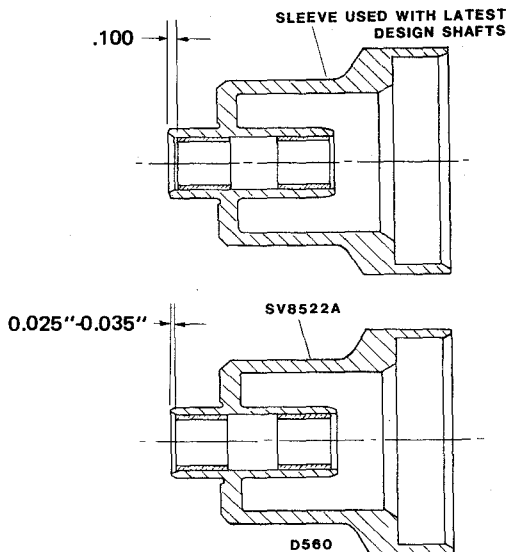
FIGURE 2.

Because of this change in design, the governor sleeve used with the new shaft **must** have a bushing recessed to a greater depth than present SV 8522A requirement. Refer to Figure 2.

When a new governor weight shaft, SH 85164 (or a weight and shaft assembly which contains this shaft) is installed in a M-100 pump, check the governor sleeve and reposition the bushing to .100" (2.54 mm) dimension if it is not at that depth. Information form (IF8536) will be packaged with appropriate shafts and assemblies indicating the need of the new (or modified) sleeve.

When a governor sleeve is being replaced and it is uncertain which governor weight shaft the pump contains, make certain governor sleeve bushing is recessed .100" (2.54 mm).

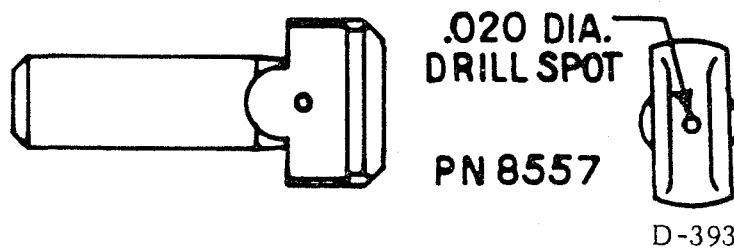
FIGURE 1.

IMPORTANT: Select a pin that will provide a .001" maximum clearance between the pin shaft and control unit bore. Dip the pin in clean calibrating oil and insert the shaft into the control unit bore. If the clearance is correct, a suction fit will result.

- (1) Replace PN 8525 pins with late production PH 8557 pins in all British Leyland pumps received for repair.
- (2) Stamp an "M" suffix behind the British Leyland part number on the nameplate when a PN 8557 or CU 8522-1A is installed in a pump - (Example: AAU 6953M). This will provide a means for identifying pumps that have been updated.

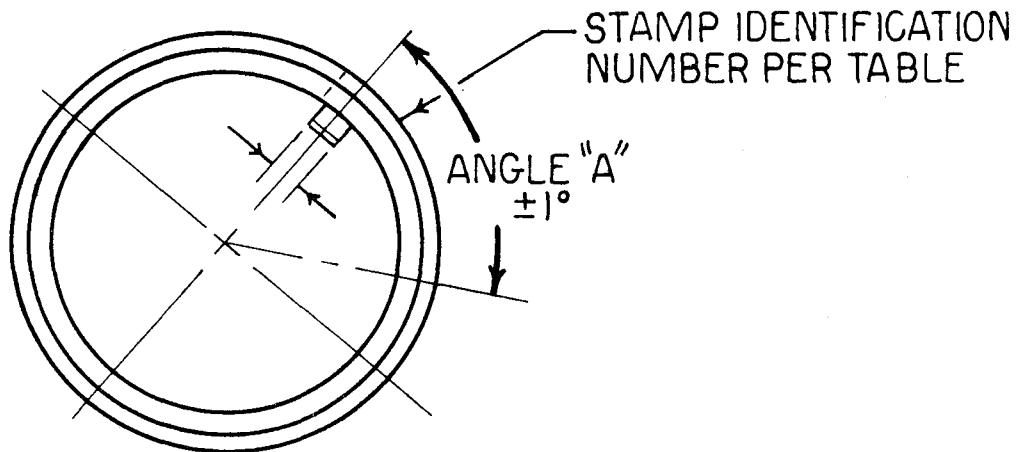
gear/hub. Face gears must not be interchanged when replaced.

NOTE: "A" is the angle between center of pin and timing mark.
