# SERVICE INSTRUCTIONS

Model 100  
Service Bulletin S1

## SERVICE INFORMATION FOR MODEL 100 INTRAVANCE® TIMING DEVICES

## Model 100 Service Bulletin S3

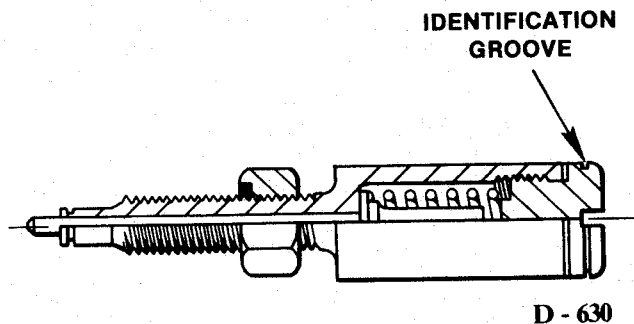
**FIGURE 1. KT85226-1**

Reports have been received indicating an inability to achieve low idle shut-off on certain M-100 pumps equipped with low idle screw capsules (KT 85226). This condition can be corrected by either modifying the existing assembly or by replacing the assembly with KT 85226-1. The new low idle screw capsule allows increased piston travel in order to achieve engine shutdown. This assembly can be identified by a groove around the O.D. of the capsule screw plug. (Refer to Figure 1).

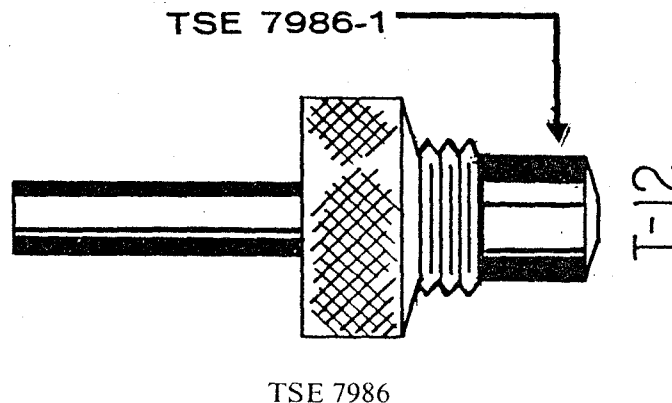
If a stalling or hard-start condition is noted with a Model 100 fuel injection pump, the cause could be erosion on the lower delivery valve body where contact is made with the hydraulic head. This stalling occurs as a result of fuel leakage past the outside of the valve body where the erosion has created a path for the fuel to travel. The condition can be corrected by replacement of the eroded delivery valve assembly. A complete delivery valve kit, which includes the delivery valve spring, holder, etc. would **not** be required, however, delivery valve opening pressure should be checked to verify it is within specified limits (1150-1450 PSI). If out of spec, a new delivery valve spring guide should be installed to obtain the proper opening pressure.

In extreme cases, erosion can damage the hydraulic head itself in the area where the delivery valve body seats. This, too, can result in leakage past the delivery valve body. If the erosion is not overly severe, the seating surface should be lapped using tool #TSE 7986 which includes lapping arbor #TSE 7986-1 (see picture below).

Lapping compound #TSE 77103, is recommended for use with the above tool and it should be applied to the lower angular surface of the arbor. The knurled portion of the tool is then threaded into the upper hydraulic head and the arbor is twisted or rotated in order to work the lapping compound against the valve seat in the head. Care must be taken to remove all the pitting, scoring or erosion in the valve seat area, leaving a smooth seating surface for the valve body.

After lapping the valve seating surface, the head should be thoroughly cleaned and flushed to remove contaminants. This includes removal of set screw (SC 1867) and sealing ball (BB 1070) so that the fuel duct can be adequately flushed.

Next, thoroughly clean and dry the threads of set screw and hydraulic head screw hole threads. Apply Loctite "Locquic Primer Grade T" to both screw and hole threads. Allow to dry for 3-5 minutes and apply Loctite #271 sealant to set screw threads. Install a **new** sealing ball into head, then install set screw and torque to 120 - 130 lb.-in. (14 - 15 Nm).

If the lapping arbor is scored or damaged during usage, the lapping surface can be machined to regain the 150° included angle which contacts the hydraulic head. The lapping arbor itself can also be ordered separately in the event that replacement of the arbor is desired.
